SMITHSONIAN INSTITUTION  
BUREAU OF AMERICAN ETHNOLOGY  
BULLETIN 51

# ANTIQUITIES OF THE MESA VERDE NATIONAL PARK

CLIFF PALACE

JESSE WALTER FEWKES

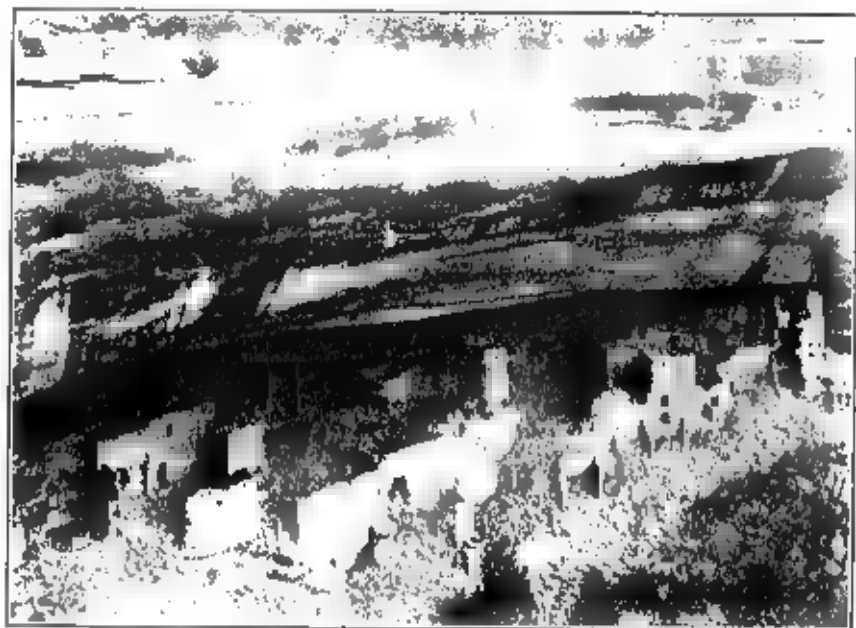
GENERAL VIEW OF THE RUIN, BEFORE REPAIRING

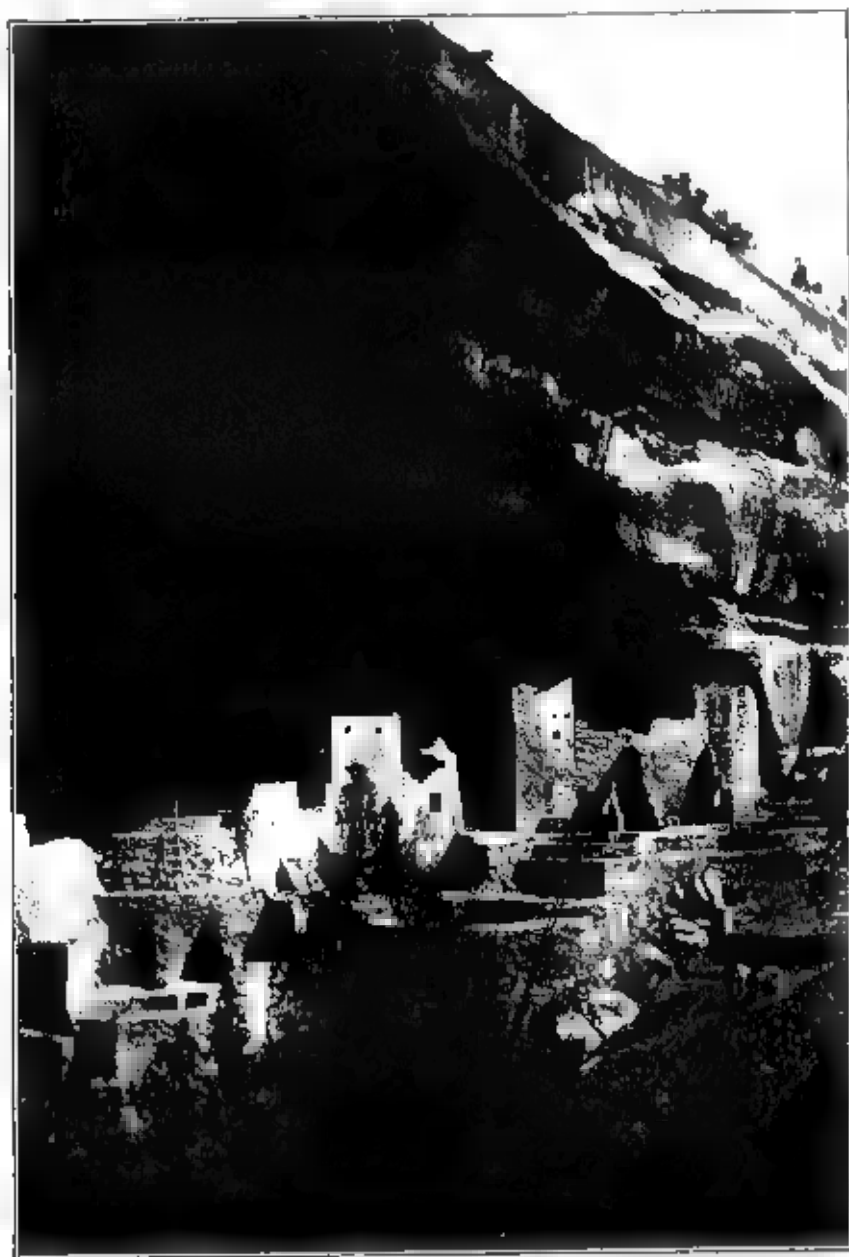
SOUTHERN END, AFTER REPAIRING

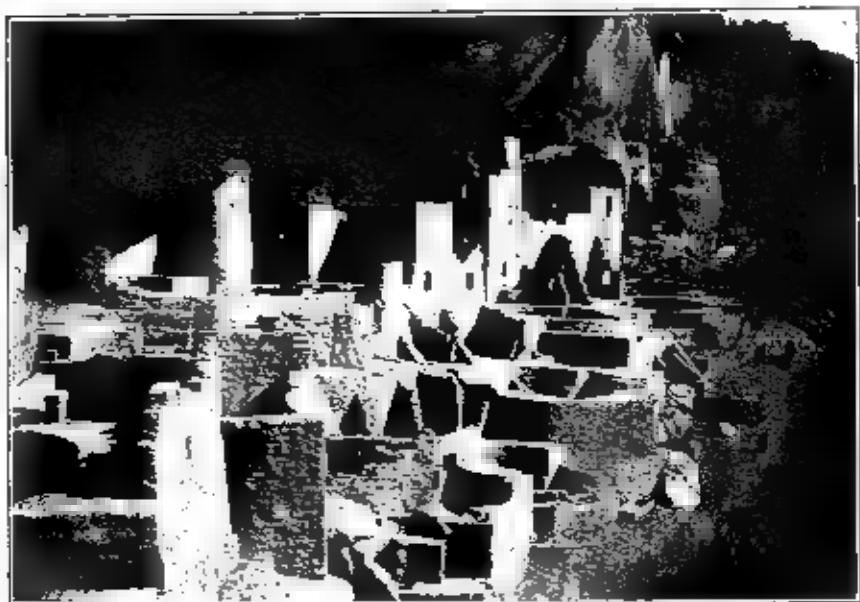
SOUTHERN END, SHOWING REPAIRED TERRACES

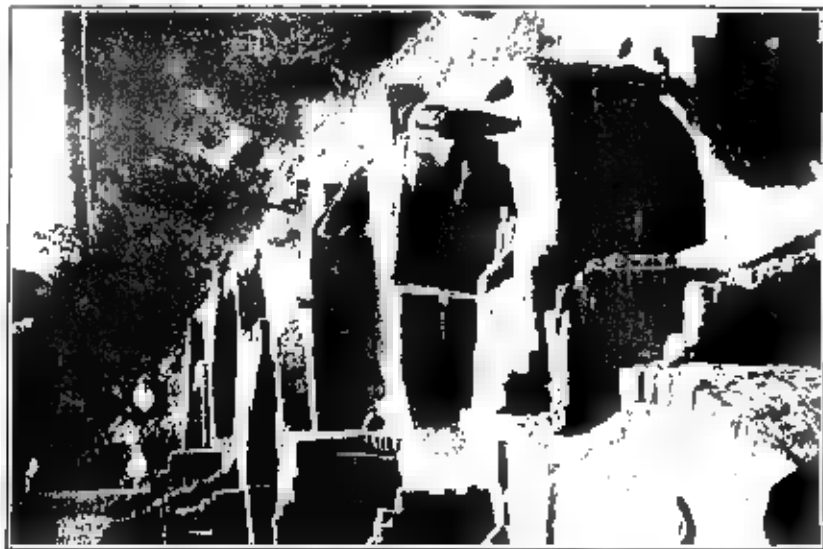
TERRACES AT SOUTHERN END, AFTER REPAIRING

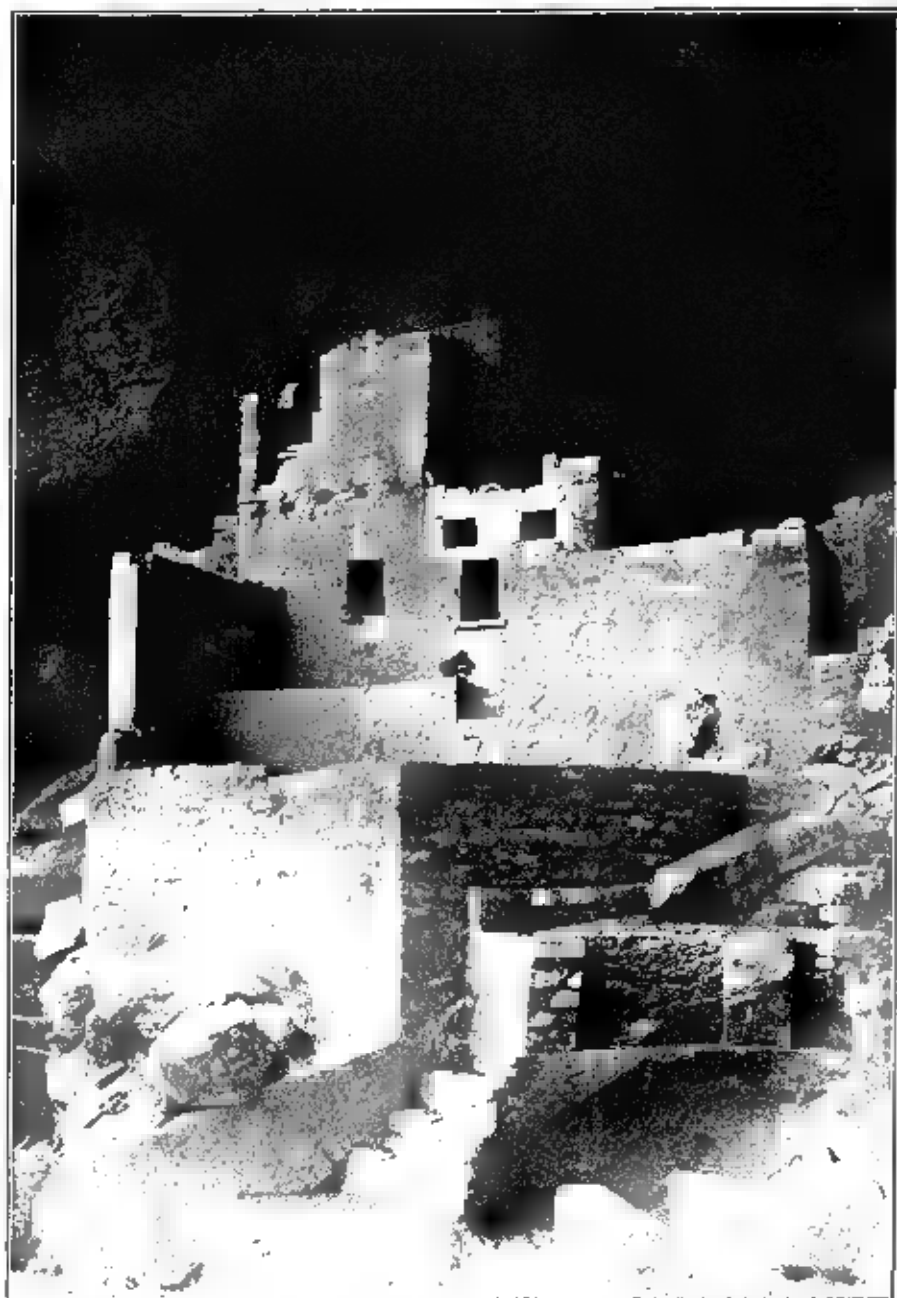
SPEAKER-CHIEF'S HOUSE, AFTER REPAIRING
